CPR Tools, Inc.

Evaluating Security Claims of the  
Cigent Secure SSD

July 1, 2021

Document No: 070121-002

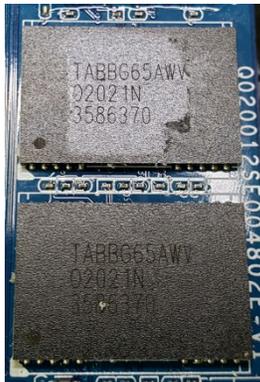
Figure 1 - Storage Chips Of Subject Drive

The examiner made note that the storage chip identifier from the exemplar 480GB drive did not match those of the target drive's storage chips, but the storage chips from the exemplar 960GB drive did match.

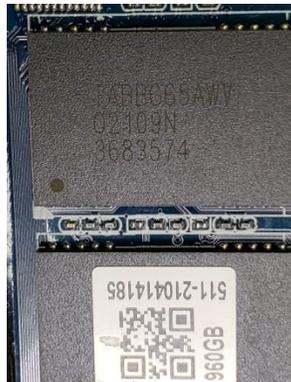
Figure 2 - Storage Chips From Exemplar 960GB Drive

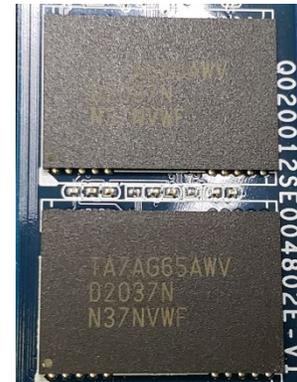
Figure 3 - Storage Chips from Exemplar 480GB Drive

The target drive reported a capacity of 480GB; the exemplar, known to be a 480GB drive, reported 480.1GB. This small discrepancy led to a more thorough physical comparison between the two. It was noted that the exemplar drive had fewer storage chips on the PCB than the target drive.

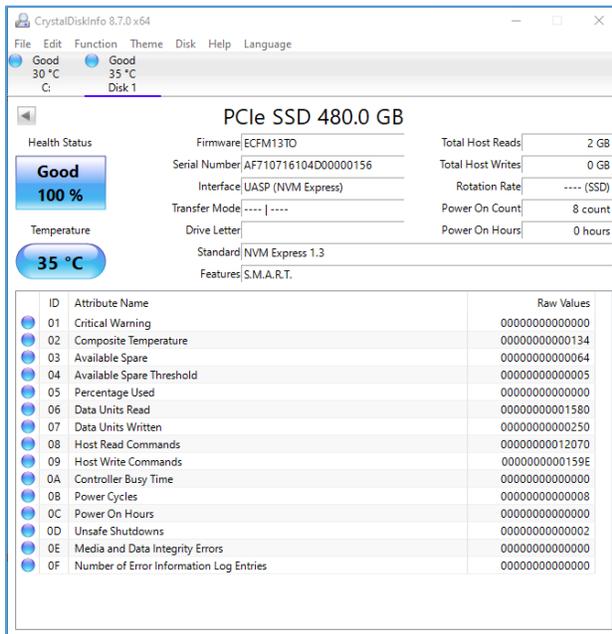
The CrystalDiskInfo utility identified the target drive as having a capacity of 480.0 GB . The same utility identified an exemplar 480GB drive as having a capacity of 480.1 GB. This 0.1GB difference is significant from a forensics standpoint, as any difference from an exemplar sample indicates a path worthy of further investigation. (See Figure 4 and Figure 5)

This seemingly minor discrepancy was an indication that while the subject drive was interpreted as 480GB capacity by the software, there was likely some kind of modification to the addressable capacity of the drive.

Figure 4 - Output of S.M.A.R.T. Utility Scan on Target Drive

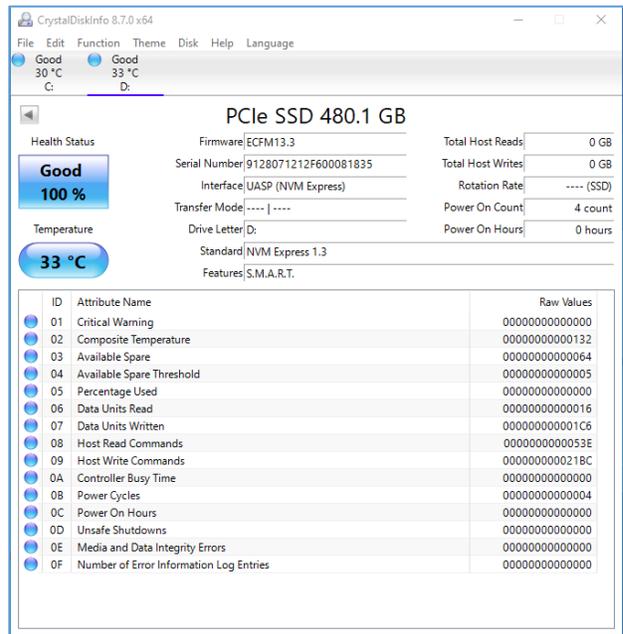
Figure 5 - Output of S.M.A.R.T. Utility Scan on Exemplar Drive

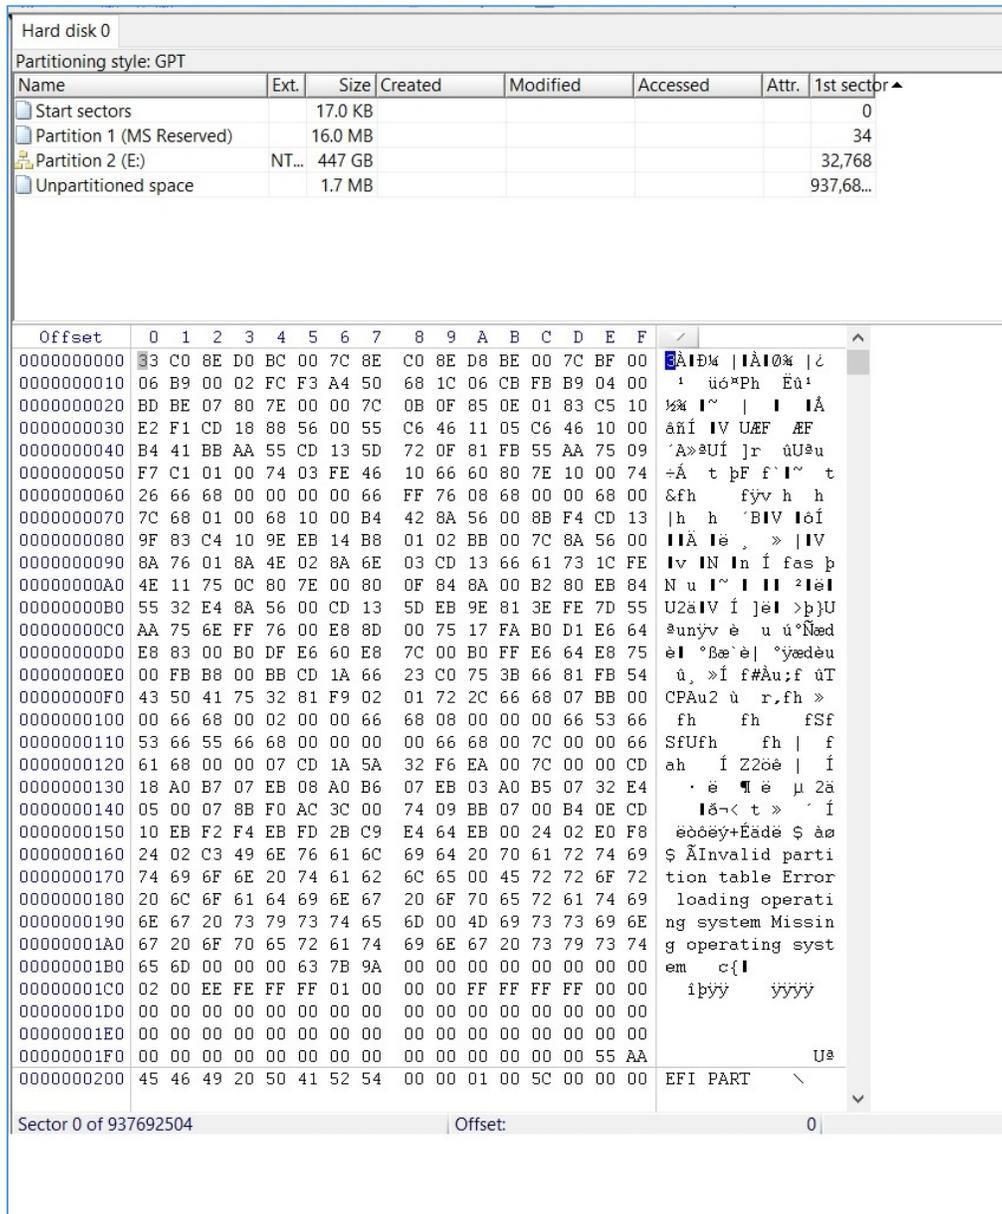
Using an industry standard Hex Editor, we found the drive to be accessible as a physical device. Scan of the device reported no errors but upon further examination, the only visible data was test data from Side A, no test data from Side B was viewable. Side A, as shown in the hex editor is depicted in Figure 6.

Figure 6 - Hex Editor display of Side A

Employing an industry standard hex editor, we examined the target drive as a physical device. The device was able to be opened. A total of 937,692,504 (480GB) sectors were able to be displayed.

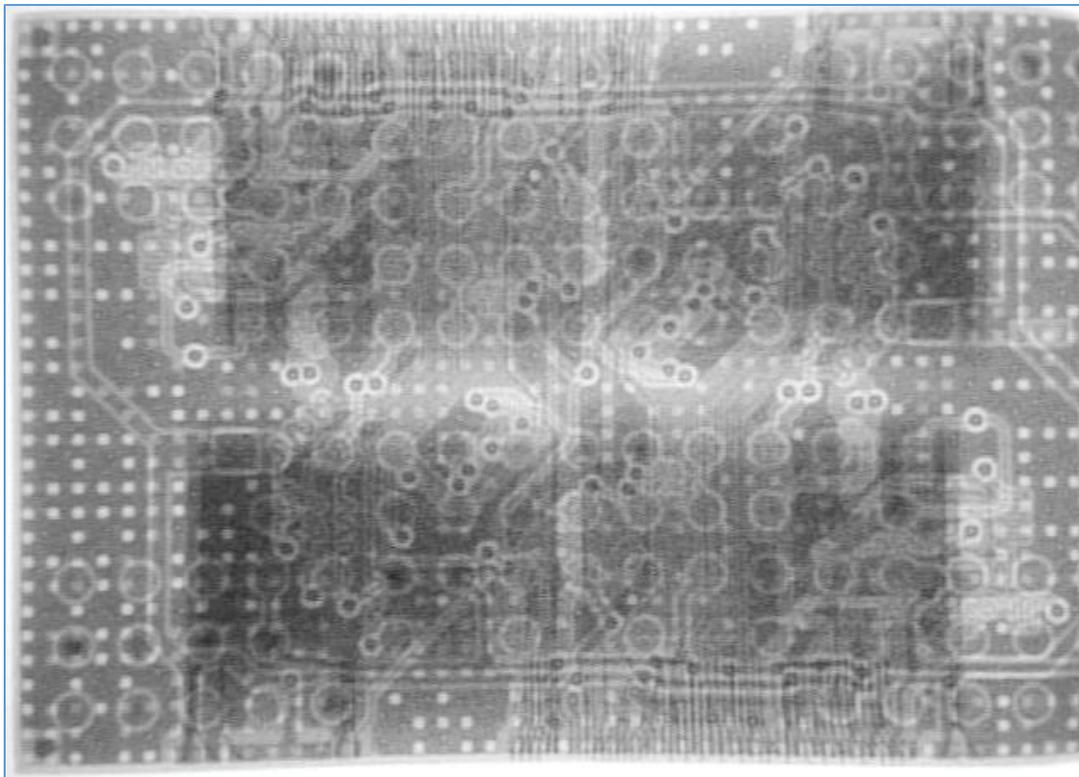
The FLASH chips were removed from the NVMe PCB. As part of our standard operating procedure when performing chip-off recoveries, we employ an X-RAY machine to review and ensure that no damage was done during the chip removal process. Figure 8 depicts the post chip-off X-RAY of the chip removed from the subject drive.

Figure 8 - X-RAY of Storage Chip Removed From Subject Drive

Examination of the X-RAY image revealed no damage to the bond wires or traces, indicating that the chip-off procedure was successful.

The FLASH storage chips were removed and examined under X-RAY to ensure that no damage was incurred during the chip removal process.

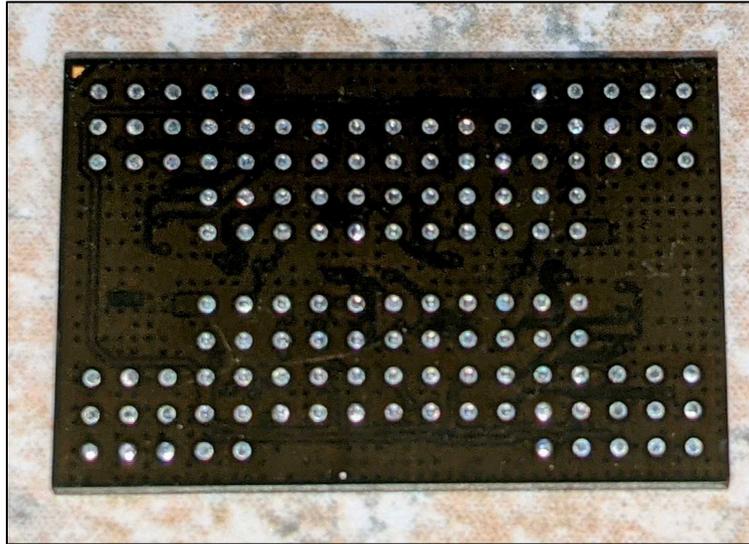
Once removed from the NVMe PCB the chips were examined directly using a BGA Chip Reader.

Figure 9 - BGA FLASH Chip

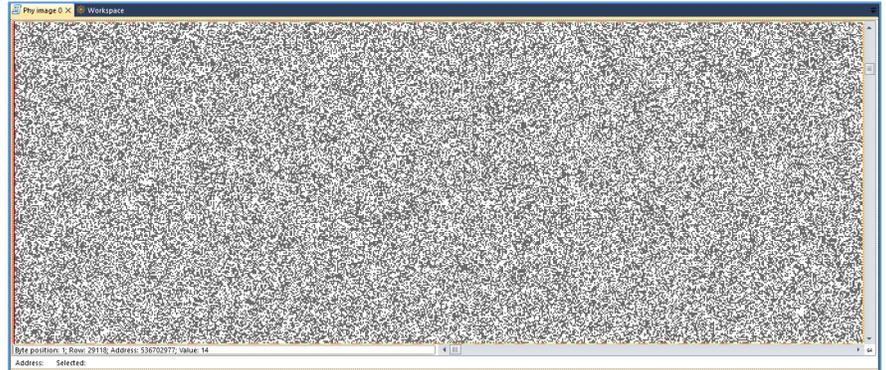
Figure 11 and Figure 12 depict “page bit” views of chip data. All white locations represent a value of zero; the locations in black represent a value of one.

Figure 11 was taken from the target drive. Given that there are no discernable patterns, we are confident that there is no viable data in this view. However, data may be present and encrypted.

Figure 11 - A page bit view of the chip data displaying no discernable patterns

The FLASH storage chips were then accessed using a BGA chip reader. Scans of the chip did not reveal any recognizable data, nor did it reveal any ECC patterns. Next, page bit views of the data were rendered and examined. All data appeared to be random which led us to believe it was encrypted and we were unable to recover any user data from the chips.
